Navajo Abandoned Uranium Mine

Site Screen Report

Leroy AUM Site

March 2010

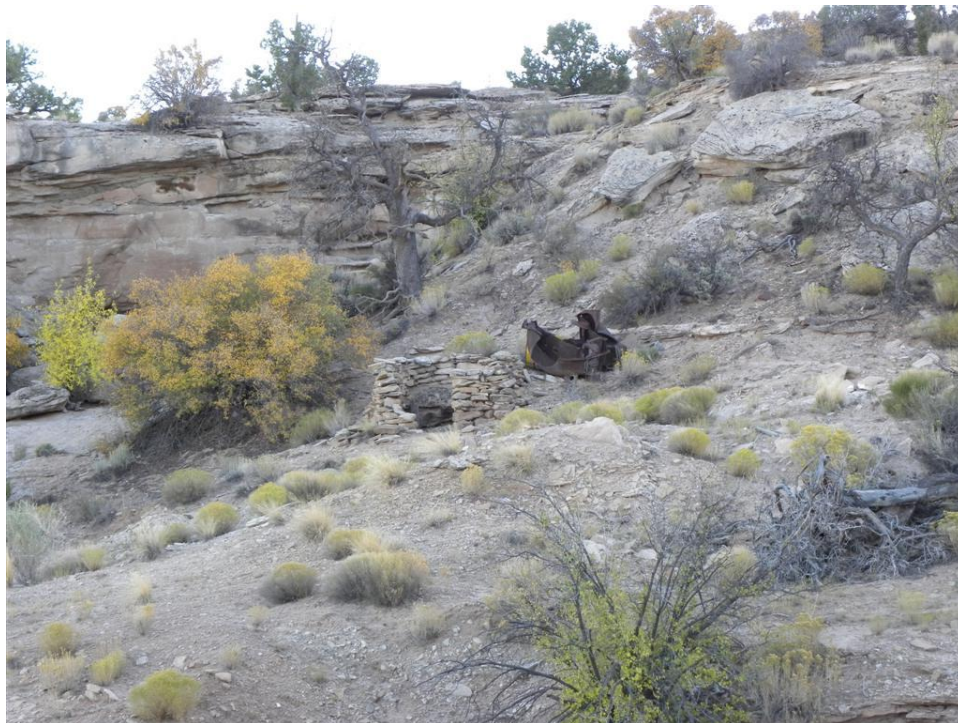
Photo 5. Stacked rock and metal debris

Some stacked rocks and metal debris
